DEPARTMENT OF TRANSPORTATION

Quality Assurance and Source Inspection

Contract #: 04-0120F4Cty: SF/ALA Rte: 80 PM: 13.2/13.9File #: 1.28**WELDING INSPECTION REPORT****Resident Engineer:**Pursell, Gary**Address:** 333 Burma Road**City:** Oakland, CA 94607**Report No:** WIR-014314**Date Inspected:** 22-May-2010**Project Name:** SAS Superstructure**OSM Arrival Time:** 630**Prime Contractor:** American Bridge/Fluor Enterprises, a JV**OSM Departure Time:** 1330**Contractor:** American Bridge/Fluor Enterprises, a JV**Location:** Job Site**CWI Name:** As noted in Summary**CWI Present:** Yes No**Inspected CWI report:** Yes No N/A**Rod Oven in Use:** Yes No N/A**Electrode to specification:** Yes No N/A**Weld Procedures Followed:** Yes No N/A**Qualified Welders:** Yes No N/A**Verified Joint Fit-up:** Yes No N/A**Approved Drawings:** Yes No N/A**Approved WPS:** Yes No N/A**Delayed / Cancelled:** Yes No N/A**Bridge No:** 34-0006**Component:** Orthotropic Box Girder**Summary of Items Observed:**

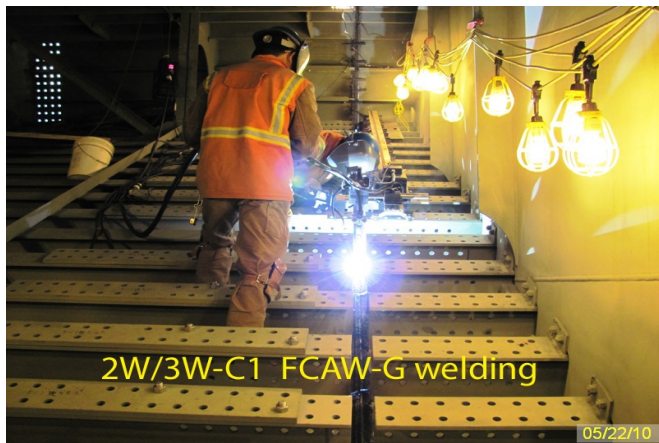
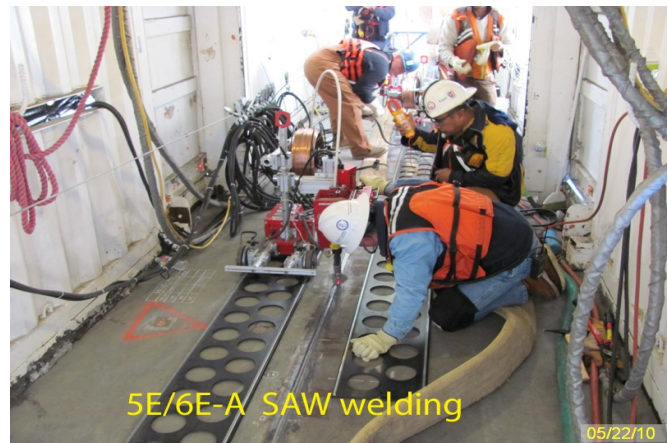
5. The QAI observed the automated Flux Cored Arc Welding (FCAW-G) process of the of the complete joint penetration (CJP) groove weld side plate field splice 2W/3W-C1. The welding was performed from the interior face by the welding operator Song tao Huang ID-3794 utilizing the Welding Procedure Specification (WPS) ABF-WPS-D15-3042B-1 Rev. 0 in the vertical up (3G) welding position. The welding was observed by Quality Control (QC) Inspector Inspector Bernie Docena. The minimum preheat temperature of 60 degrees Celsius and maximum interpass temperature of 230 degrees Celsius was verified utilizing Tempilstik temperature indicators. The FCAW-G fill pass average amperage of 250 DC, voltage of 24.3 DC at the welding lead and average travel speed of 300 millimeters per minute were verified to be within the WPS parameter ranges of 214 to 267 DC amps, 20.9 to 24.4 DC volts and travel speed of 188 to 455 millimeters per minute by the QA inspector. At the end of this shift, the welding was not completed and appears to be in general compliance with contract documents.
